## Averted Piping Failure—Earth Dam on Permeable Foundation

Scott Newhouse

*Bechtel Power Corporation, Frederick, MD*

## AVERTED PIPING FAILURE—EARTH DAM ON PERMEABLE FOUNDATION

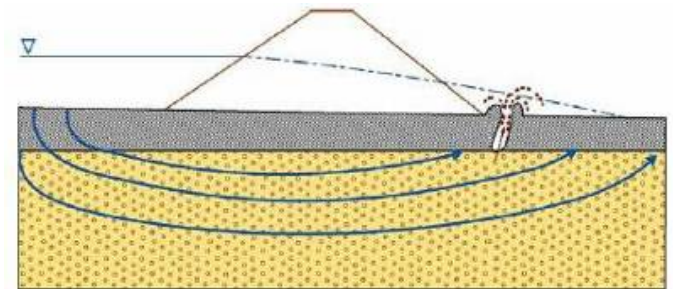
Figure 4 is taken from Danny McCook's *A Comprehensive Discussion of Piping and Internal Erosion Failure Mechanisms* (McCook, 2004). This figure illustrates a potential piping failure mechanism for conditions similar to those at the Lake Mailande Dam (Fig. 1). Figure 4 depicts a homogeneous embankment built on a thin surficial clay layer overlying a sand aquifer. McCook notes that such a

mechanism is a well established one related to failure of flood protection levees, and is more common in levees than in dams. He points out that the mechanism is actually rare in failures of earth dams.

Fig. 4. Potential Foundation Piping Mechanism: Heave caused by excessive seepage pressures under surface clay blanket. Piping of sand aquifer occurs from flow of water through defect in clay blanket, creating sand boil at ground surface. (From McCook, 2004)

Could the mechanism illustrated in Fig. 4 form in the Lake Mailande Dam when the lake is filled?

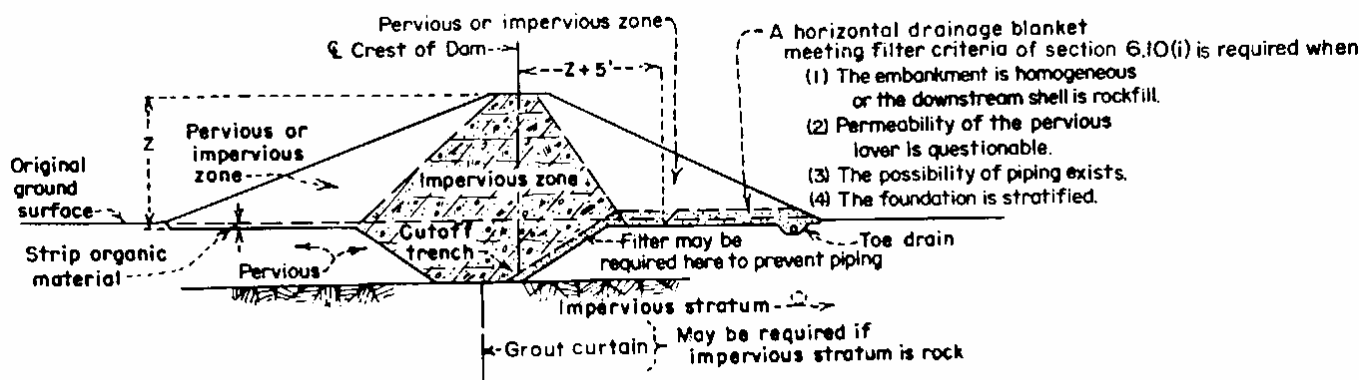
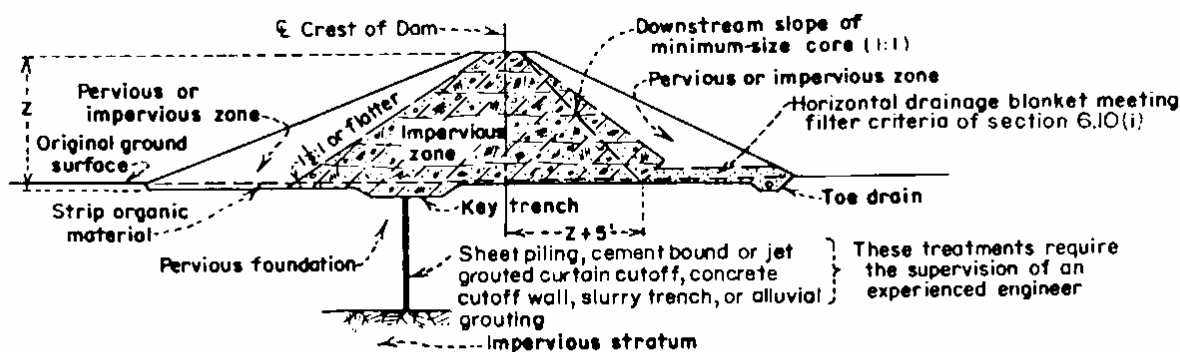
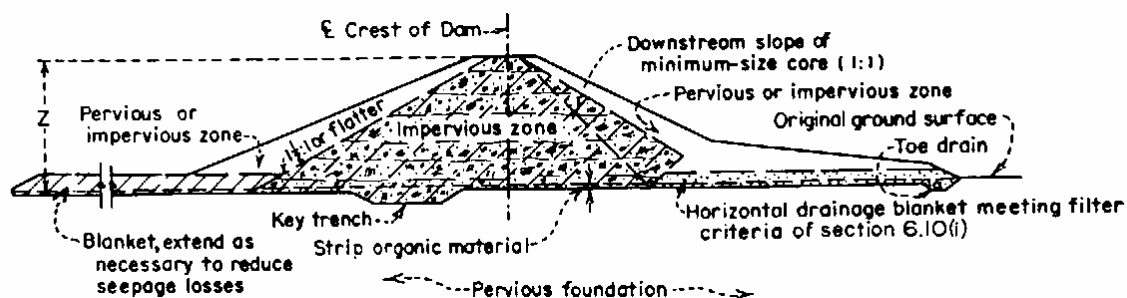
Fig. 6. Seepage Control for Permeable Foundations (From Bureau of Reclamation, 1987)

NOTE: Filter criteria given in section 6.10(i) applies between the impervious zone and any downstream zone or a properly designed filter must be provided on (A), (B) and (C).
